Genius Engineering & Service Co., Ltd.

GT GENERATOR (GT21) TRIPPED BY VOLT PER HZ ROOT CAUSE ANALYSIS (RCA) REPORT

Rev.1: 01 SEPT 2018

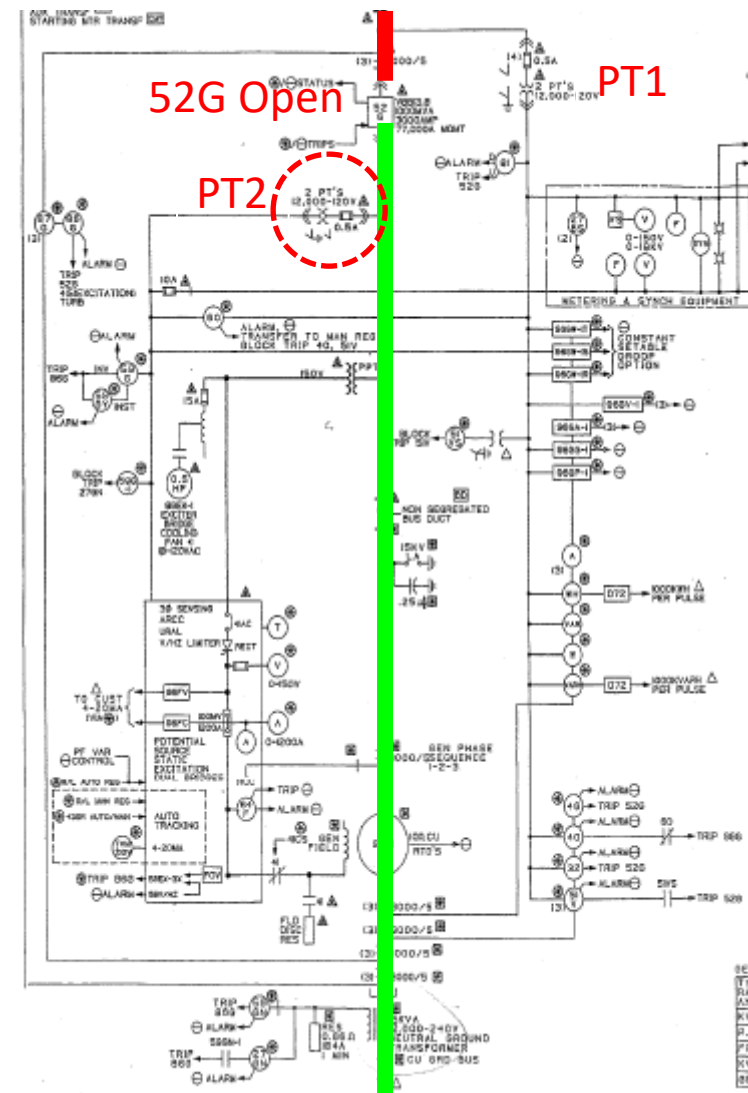
Status After UNIT Tripped

Relay 60 connected directly to PT2

Voltage
feedback
signal
to Excitation
System

Initiated bus potential transformer trouble

Initiated bus potential transformer trouble alarm

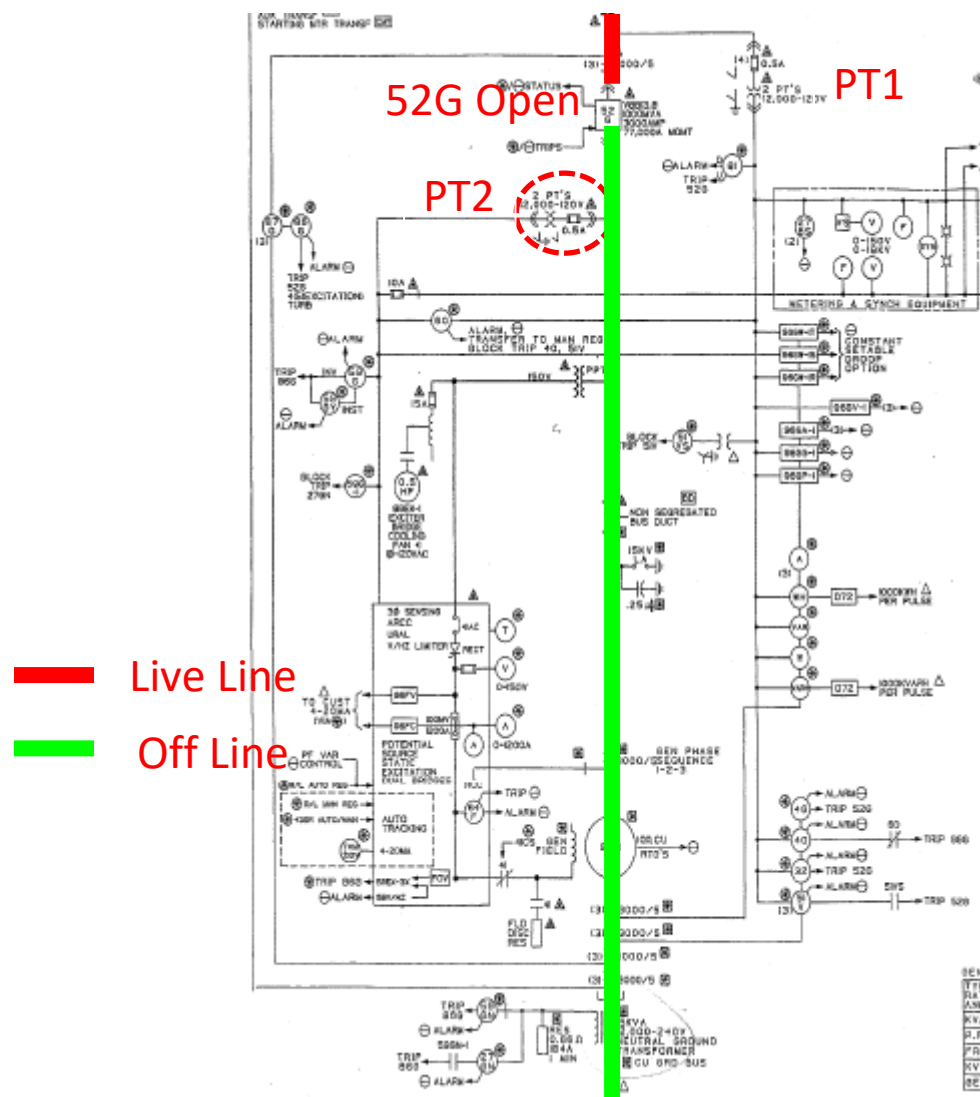
If PT2 fail cause Relay 60 operated then initiated alarm “Bus potential transformer trouble alarm”. And PT2 also send voltage feedback signal to Excitation System if no voltage appear on Excitation System means it don’t see the actual voltage. So it will generate more field current to rotor filed winding to try to increase generator voltage then cause excessive volt per hertz alarm.

This lead to investigate PT2.

Note – Volt per Hertz is overfluxing protection used to prevent generator stator core damage from heat due to high flux.

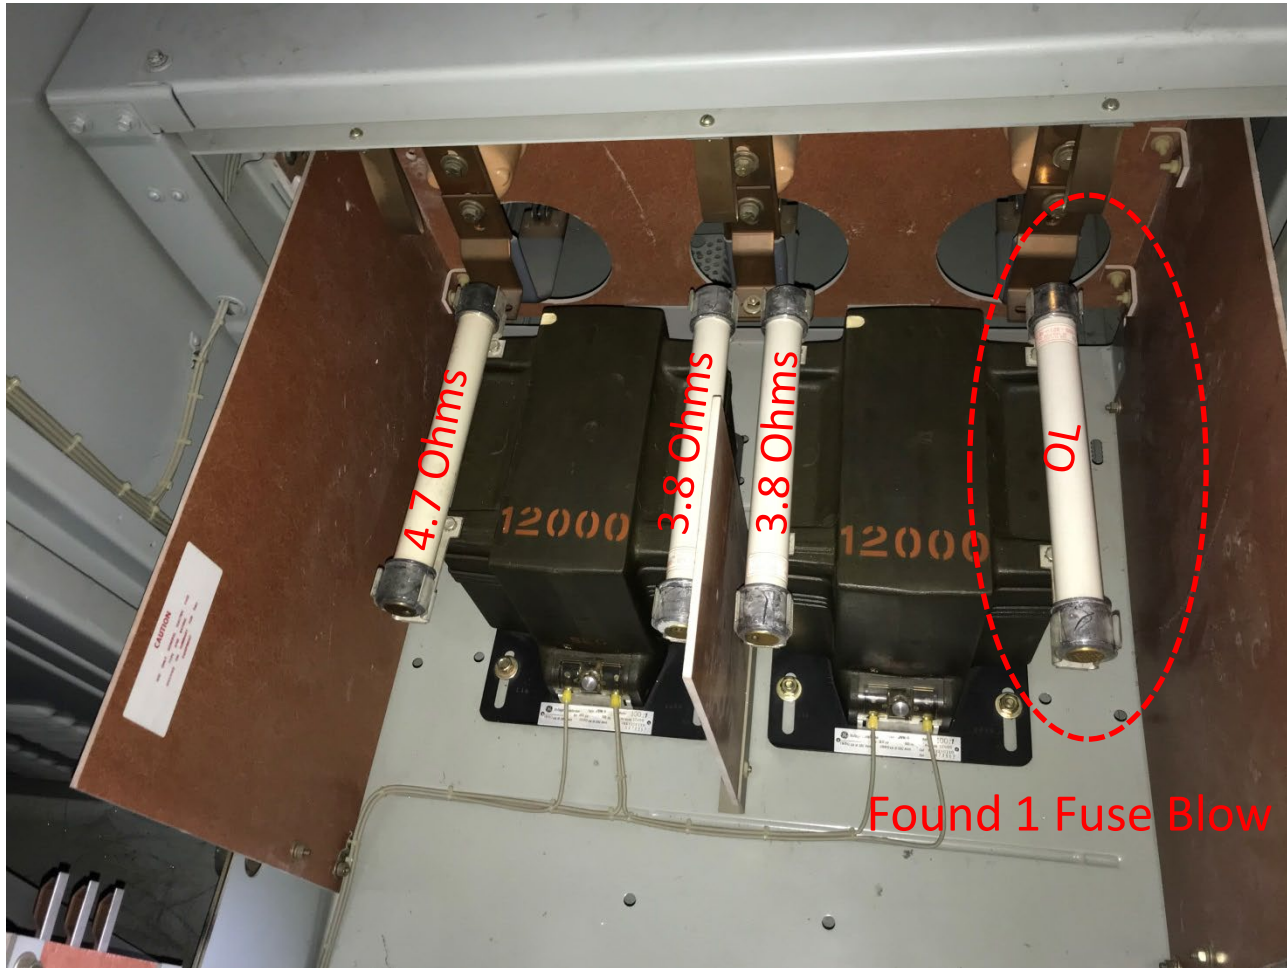
Fuse resistance measurement & record

- The fuse of PT1 and PT2 should be routine inspected, measured and recorded the resistance. We found 1 fuse of PT2 was high resistance (4.7 Ohms) compare to other 2 good fuses (3.8 Ohms) this can lead fuse to be hot then blow. Such fuse shall be replaced.

Two Fuses has been replaced (Blow one and the another one that has quite high resistance compare to the perfect good one).

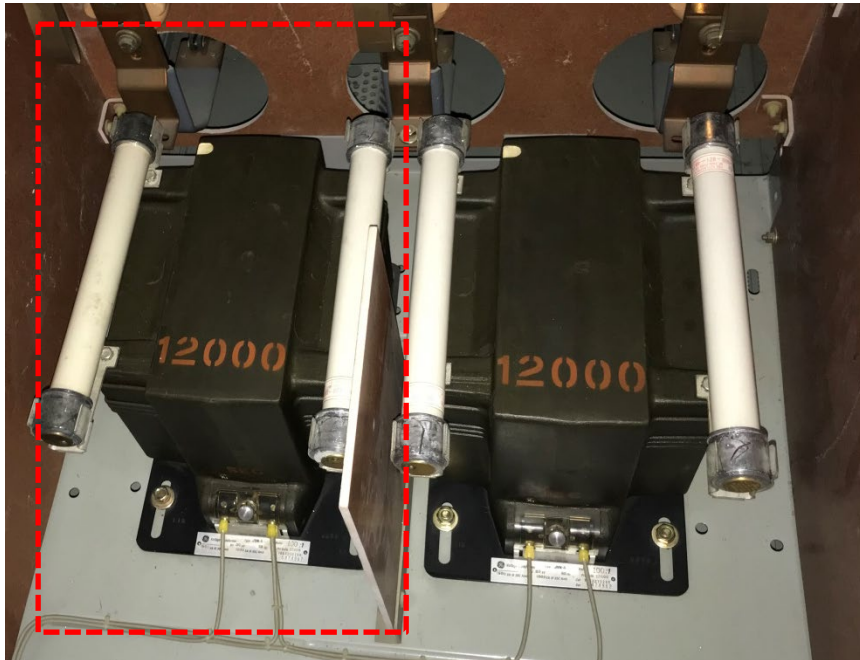
Left Side PT2

ELECTRICAL TEST	RESULT	EVALUATION
DC Winding Resistance Test	HV: 893 Ω LV:151.5 m Ω	Passed
Ratio Test	99.756	Passed
Insulation Resistance (IR) Test	919 G Ω	Passed

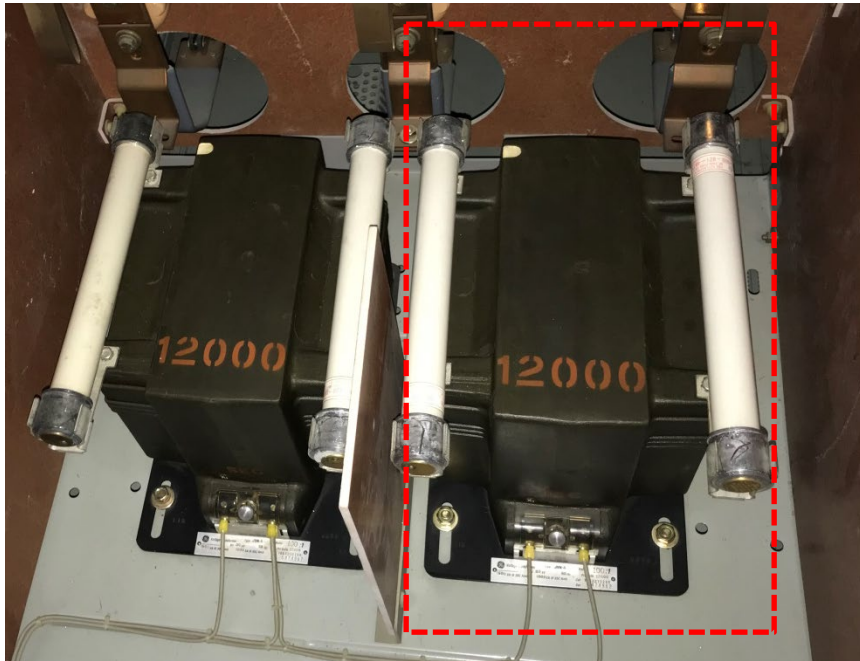
Right Side PT2

ELECTRICAL TEST	RESULT	EVALUATION
DC Winding Resistance Test	HV: 895.5 Ω LV:151.89 m Ω	Passed
Ratio Test	99.734	Passed
Insulation Resistance (IR) Test	583 G Ω	Passed

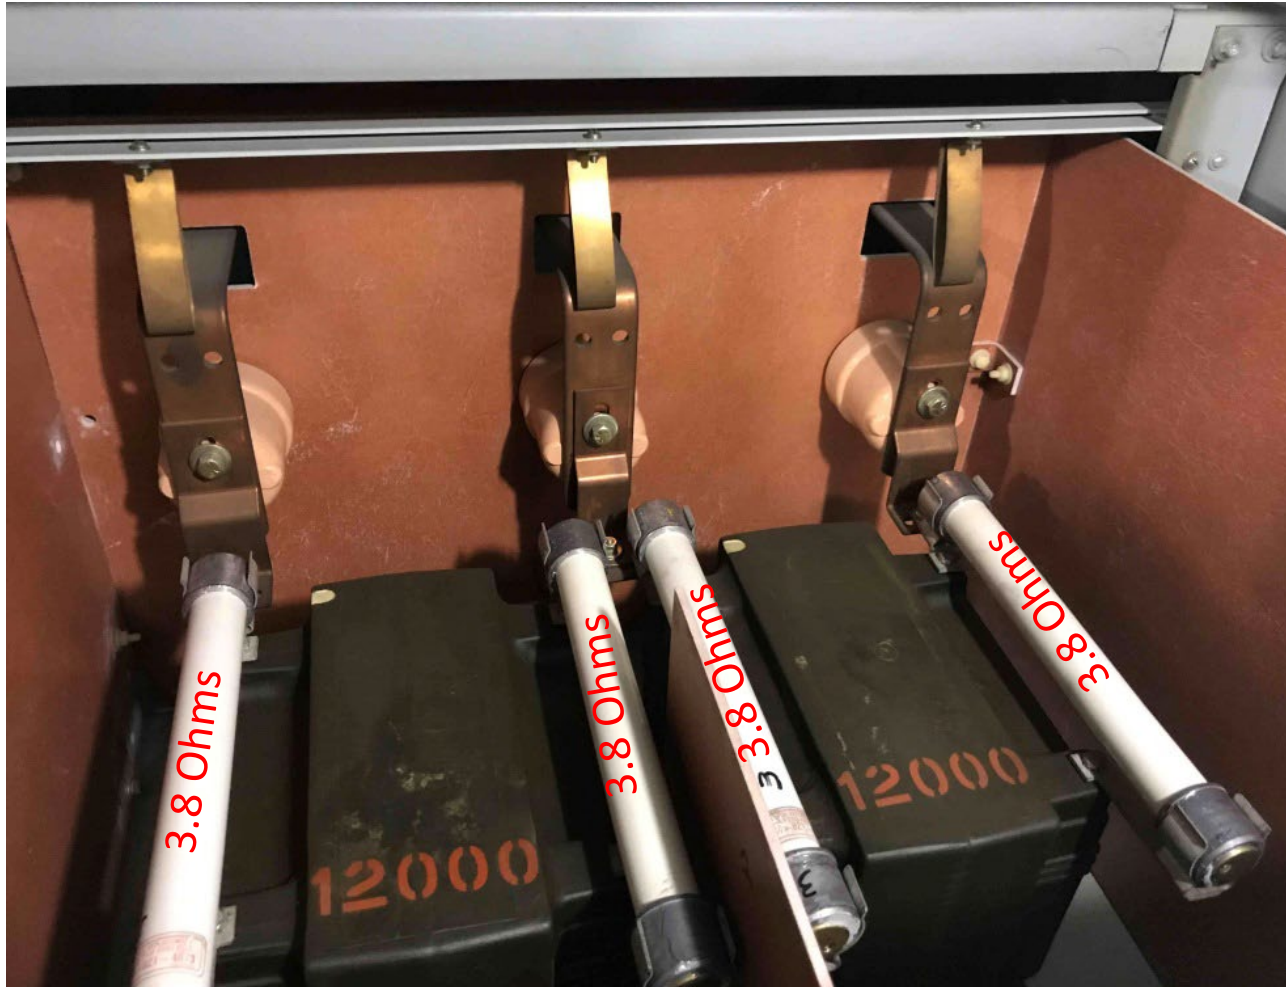
Fuse resistance measurement & record

One PT2's
Fuse Blow

- Defect of fuse itself
- Load of fuse shorted, in this case load of fuse is PT2 which we have verified that the PT2 still be Okay by electrical test

Therefore, we conclude that the root cause of the problem come from blow fuse.

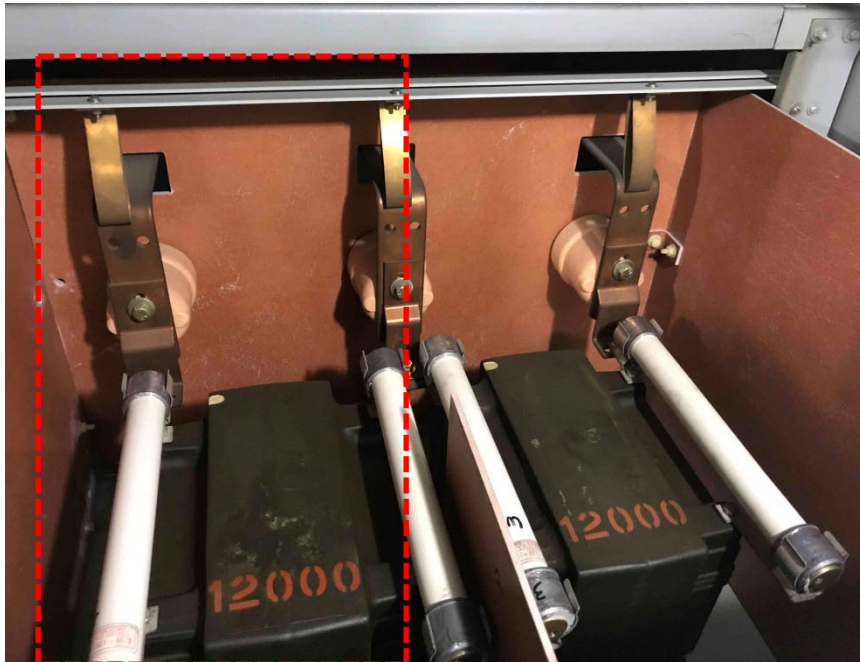
Left Side PT1

ELECTRICAL TEST	RESULT	EVALUATION
DC Winding Resistance Test	HV: 912.1 Ω LV:154.4 m Ω	Passed
Ratio Test	99.765	Passed
Insulation Resistance (IR) Test	171 G Ω	Passed

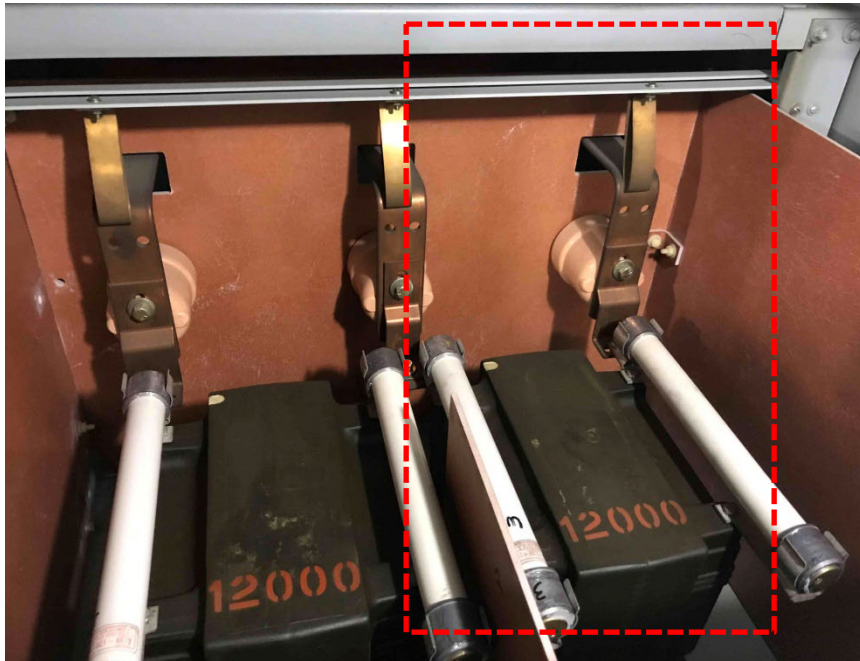
Right Side PT1

ELECTRICAL TEST	RESULT	EVALUATION
DC Winding Resistance Test	HV: 909.5 Ω LV:154.4 m Ω	Passed
Ratio Test	99.738	Passed
Insulation Resistance (IR) Test	1720 G Ω	Passed
